Manhole Inspection Summary

Manhole # S37S__024MH

Insp Date: **2/20/08 1:39 PM**

Location Address: **500 clement**

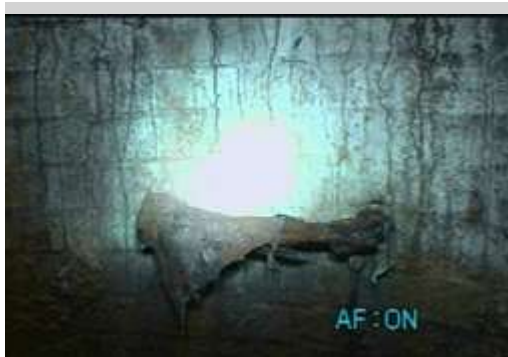
Defect 1

Steps Count: **4** Missing: **1** ☒ **Corroded**

Surcharge ☒ **Evidence Of Surcharge** Depth: **6** (ft.) ☐ Active Surcharge Present

corroded steps and evidence of surcharge

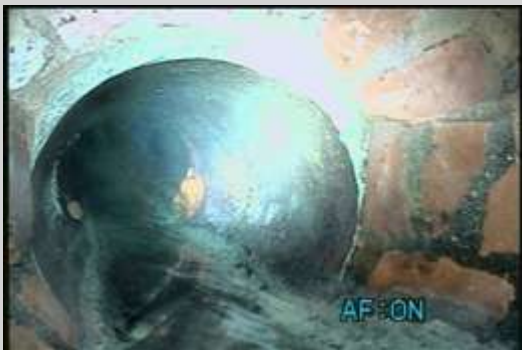
12 O'Clock Outflow

8 in. Circular Gravity Sewer
Pipe Out @ 12 O'Clock

Invert Depth: **7.80** (ft.) Flow Characteristics: **Fast**

Infiltration: **None** Pipe Seal Cond: **Unknown**

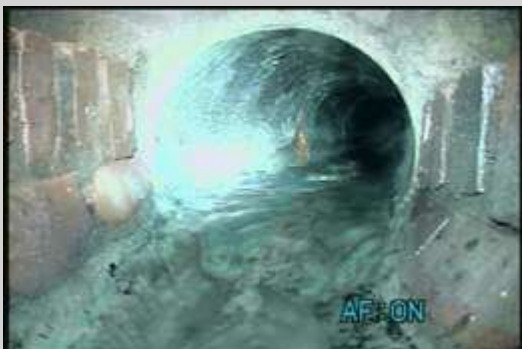
9 O'Clock Inflow

8 in. Circular Gravity Sewer
Pipe In @ 9 O'Clock

Invert Depth: **8.10** (ft.) Flow Characteristics: **Fast**

Infiltration: **None** Pipe Seal Cond: **Unknown**
